## 1.0 UNIT / INSPECTION DETAILS

| <b>Report Reference</b> | ETI/SJI/SCSL/E111/PR/21 |
| <b>Client</b> | Shell Chemicals Seraya Pte. Ltd. |
| <b>Component S/N</b> | E111 – Recycle Water Cooler |

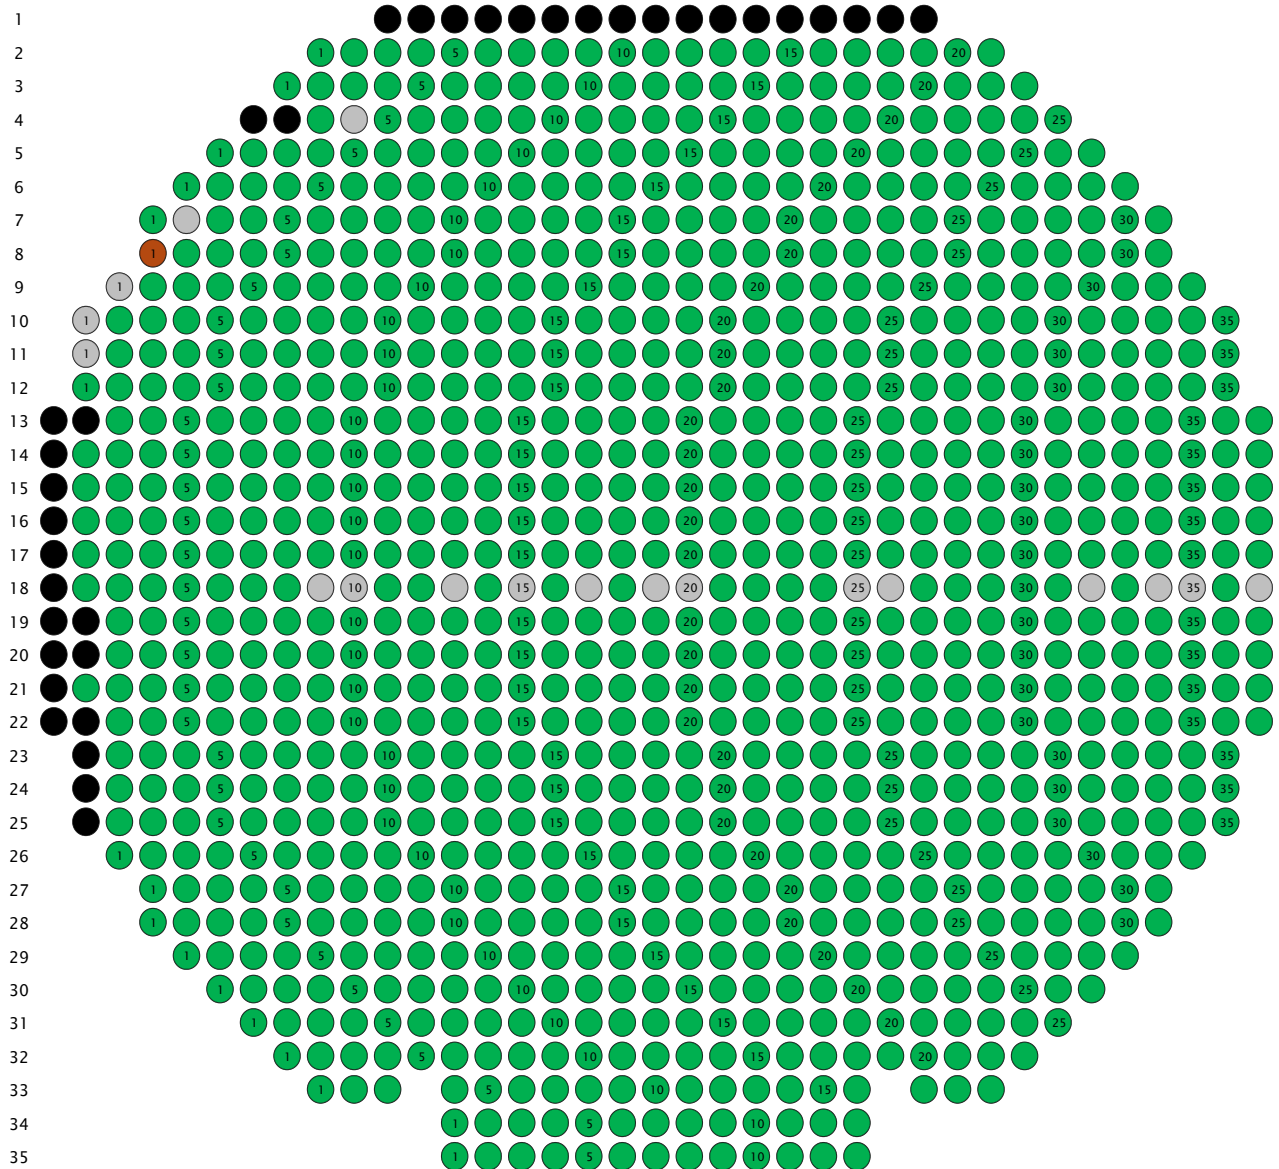
ECT & IRIS inspection on E111

1. *External corrosion was observed in all the tubes inspected, resulting in a maximum of  $\leq 20\%$  wall loss. The corrosion was predominantly seen between the stationary tubesheet side and 2<sup>nd</sup> baffle as counted from the stationary tube sheet side and in some cases it was observed to be scattered along the entire tube length. IRIS cross verification on some randomly selected tubes confirmed the presence of external corrosion with a maximum of 13% wall loss.*

| WL ≤20% OD | 1006 | 94.8% |
| WL ≤20% OD & PB | 18 | 1.7% |
| Blocked | 1 | 0.1% |
| Plugged | 36 | 3.4% |
