# **E9207 aircooler leak learnings**

## E9207 aircooler leak

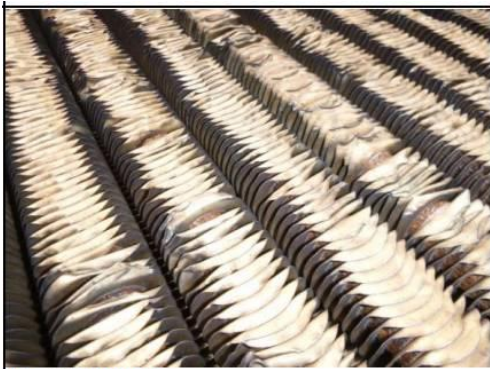
Fig. 12: Tube fins  
Almost fins were slightly deformed at top side.

- Top row finned tube bowing
- Suspected there since 2008
- Damaged finned tubes will be hotter causing more tubes expansion

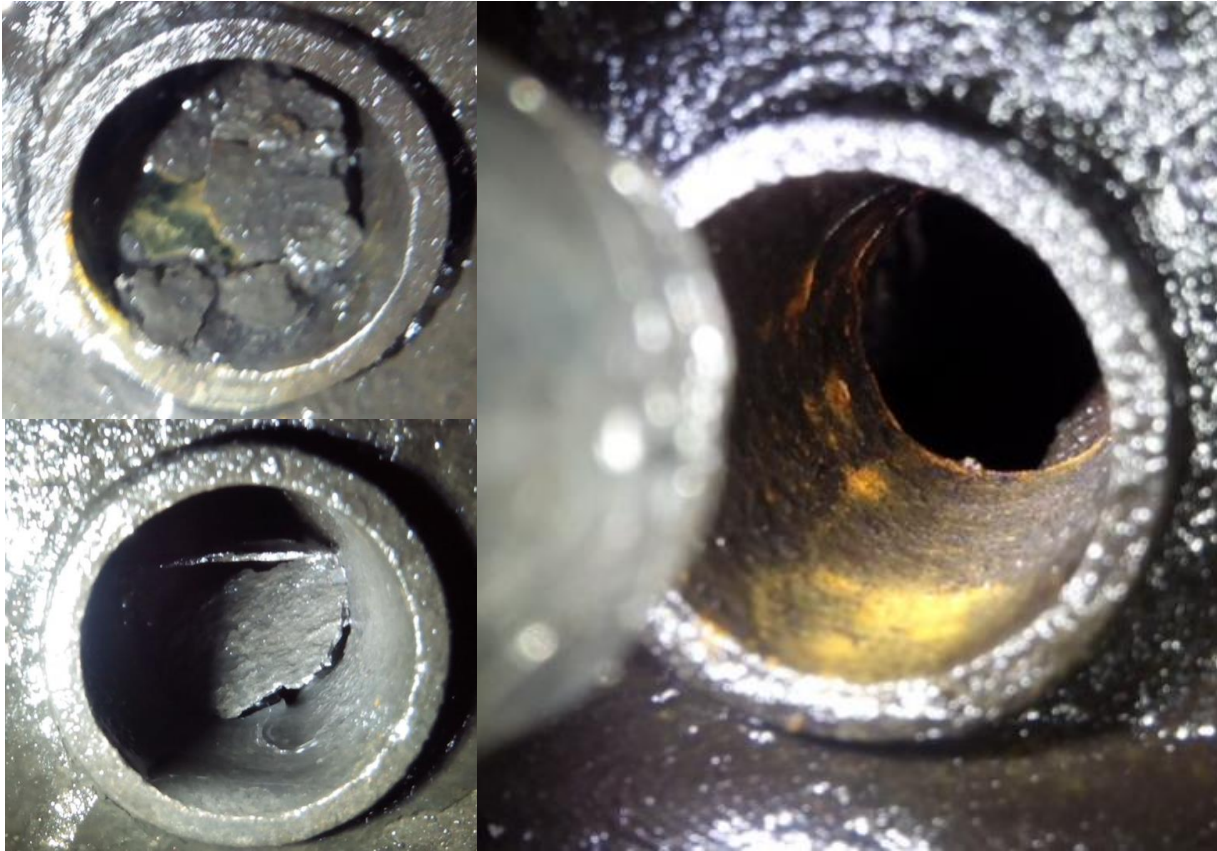
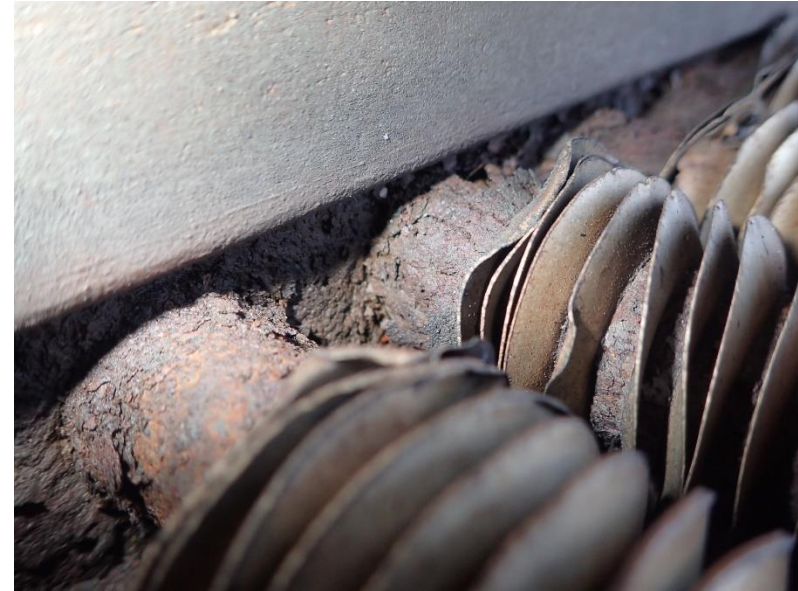
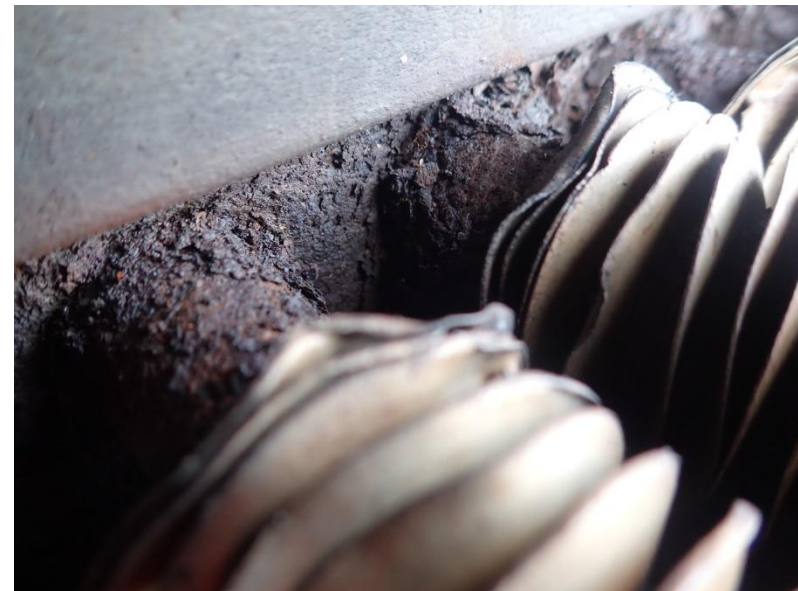
- Tubes internal found with internal deposits and scales
- Observed one tube completely sheared off

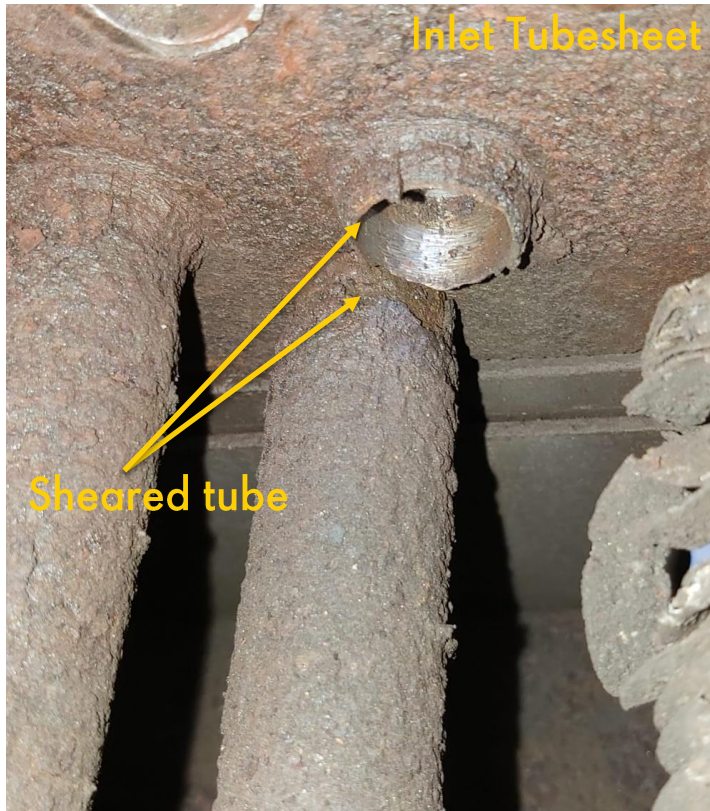
1. As found tube

- Leaking tube was found completely sheared at inlet tubesheet.
- Severe localized external corrosion was observed on the tube OD adjacent to inlet tubesheet. Internal corrosion was negligible.
- Remaining tube thickness adjacent to sheared face was  $<0.4\text{mm}$  as compared to  $2.2\text{mm}$  away from sheared face.

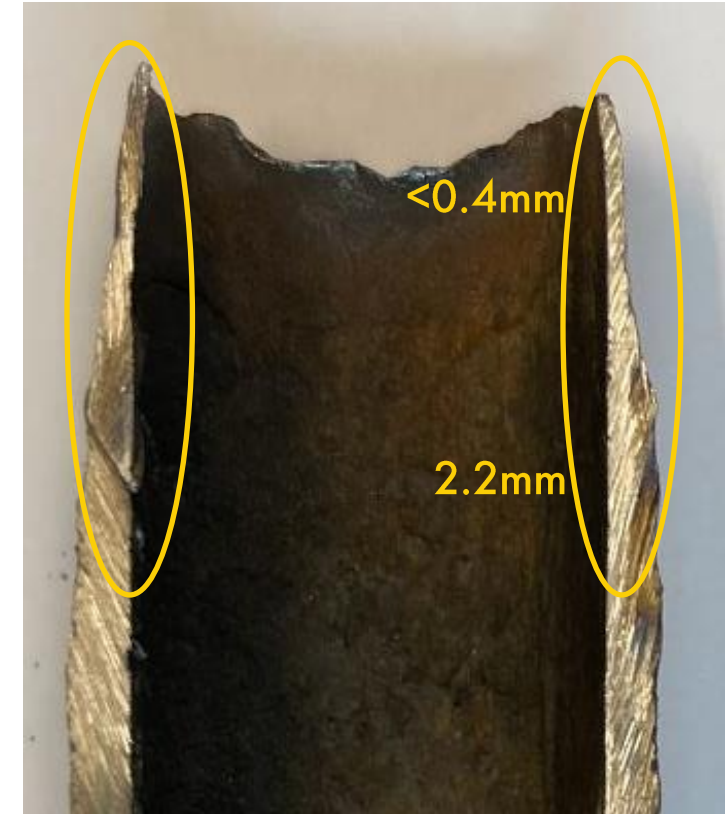
4. Thickness loss from OD

- External Atmospheric Corrosion over long term
- Long Term Corrosion Rate, 2.2mm lost in 38 years = 0.06mm/year
- Corrosion rate looks reasonable in terms of atmospheric corrosion for marine environment
- External aluminium fins also acts as a sacrificial galvanic couple for carbon steel tube hence prevents corrosion at finned section
- Therefore, tube ends are more prone to external atmospheric corrosion

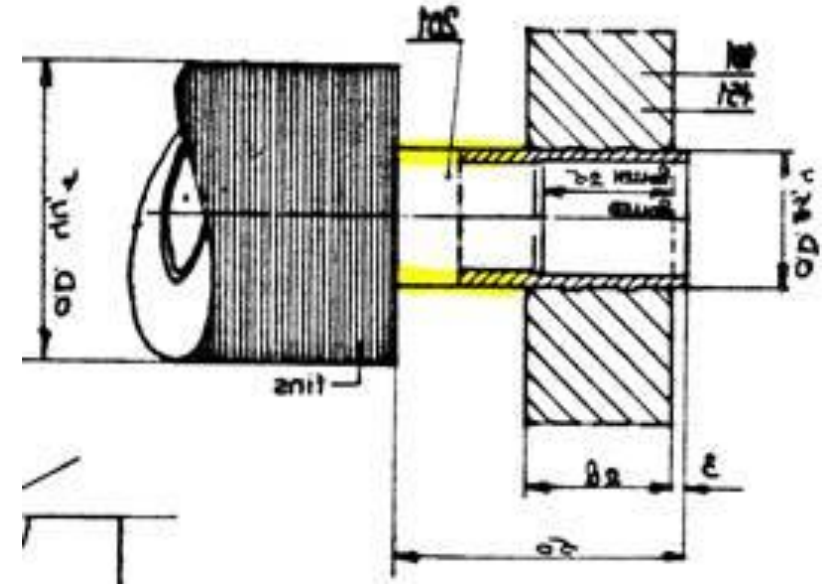
Comments: External Pitting

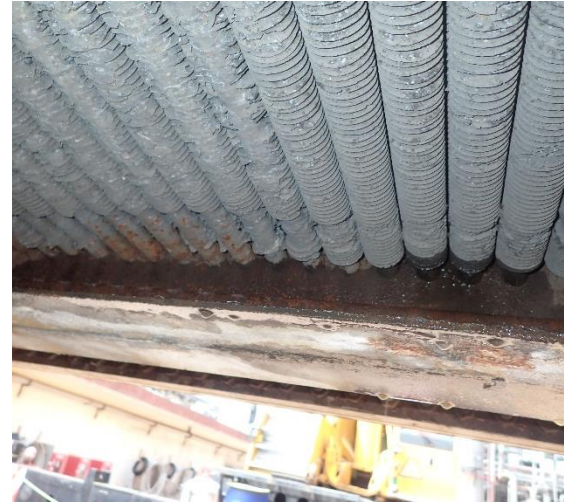
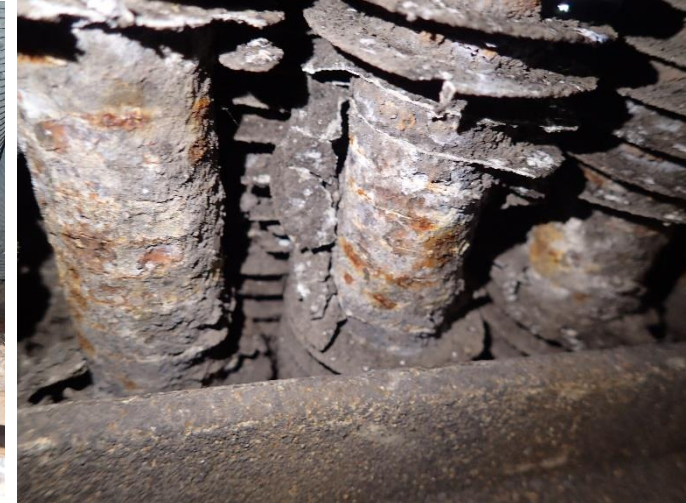
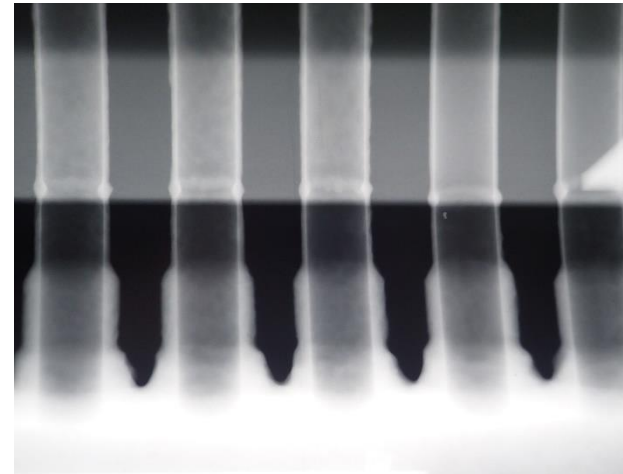
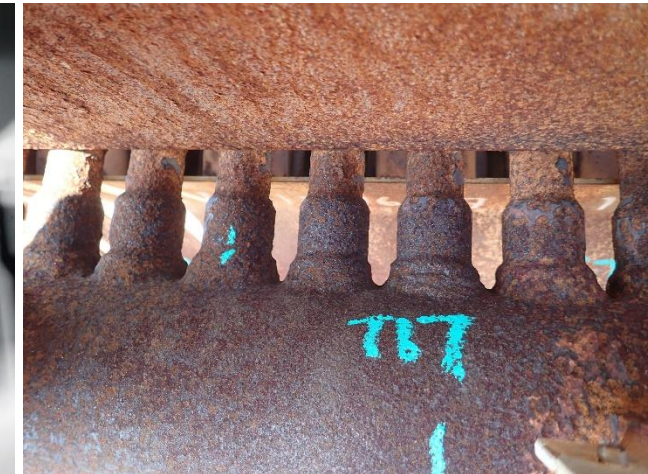
- CD5 2016 TA E8530-2 leaked due to external corrosion at bare section
  - As part of the investigation, 14 ACHE were identified for a thorough close visual inspection from the cowl and 11 were identified with corrosion and planned for replacement in next TA. Out of which, 3 were identified for hydrotest to ensure they last till the next TA.
- PLAT4 2021 E9904 paper thinned tubes at the unfinned section in 2021.
  - ACHE isolated and planned for re-tubing

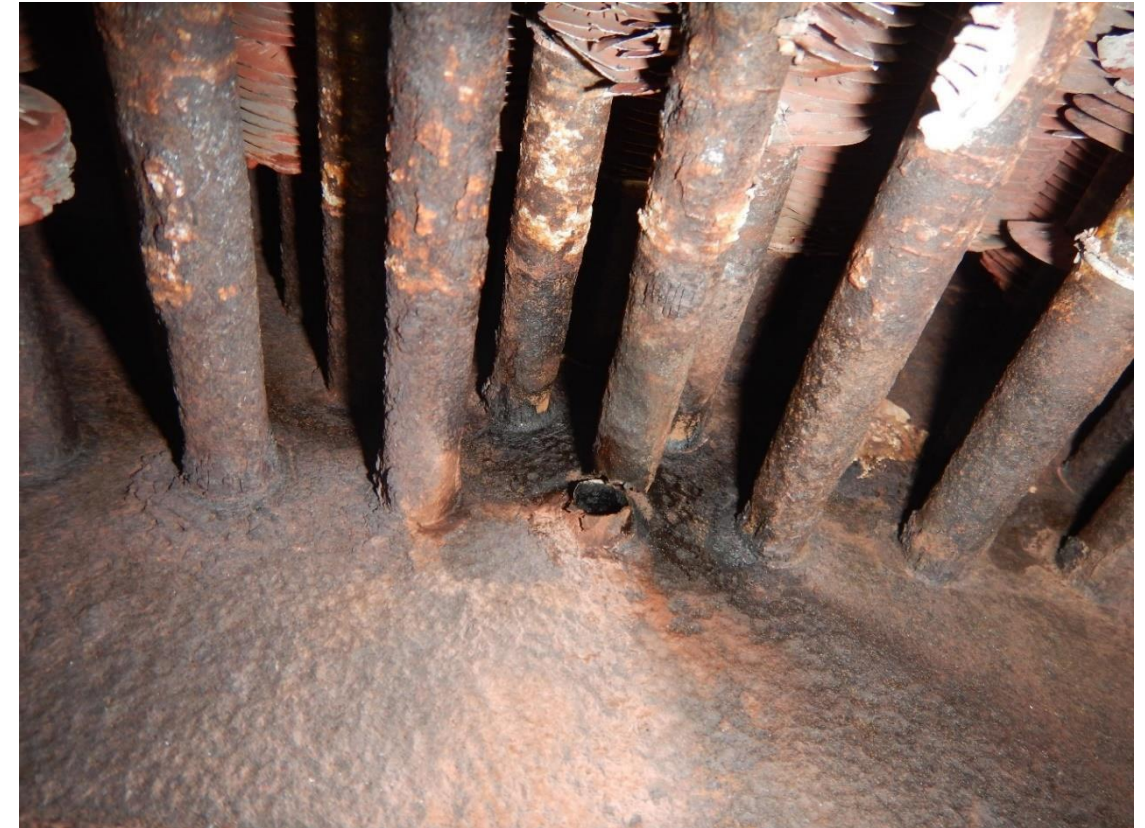
- Ursa Platform, Gulf of Mexico (Marine Environment).
- HAL-1062 (2<sup>nd</sup> Stage Discharge Cooler for Field Gas Compressor-2).
- Tube **rupture** on November 25, 2020.
- Tubes: 0.625" OD x 0.083" wall (A-179 with L-footed Fins).
- Exposed tube ends coated with a **Phenolic coating**.
- MAWP = 2200 psig,  $t_{\min} = 0.049$  inches (**Available CA = 0.034 inches**).
- Gas inlet temperature ~305 °F, **intermittent service**.
- ACHE installed new in 1999.
- Tube thickness at the rupture site was ~0.015 inches. (0.375mm)
- Corrosion Rate =  $(0.083 - 0.015)/21 = 3.2$  mpy.
- Corrosion rate calculation assumes the coating failed immediately after the ACHE was placed in service.
- Localized external corrosion at a few tubes in the bottom row.
- Tube rows 1, 2, and 3 with significantly less wall loss.
