# **PU2 - CD4 SCW HEX Reliability Improvement**

**Hydraulic Threats Assessment to SCW Coolers**

**Tiger Team with PU2 Ops & Tech**

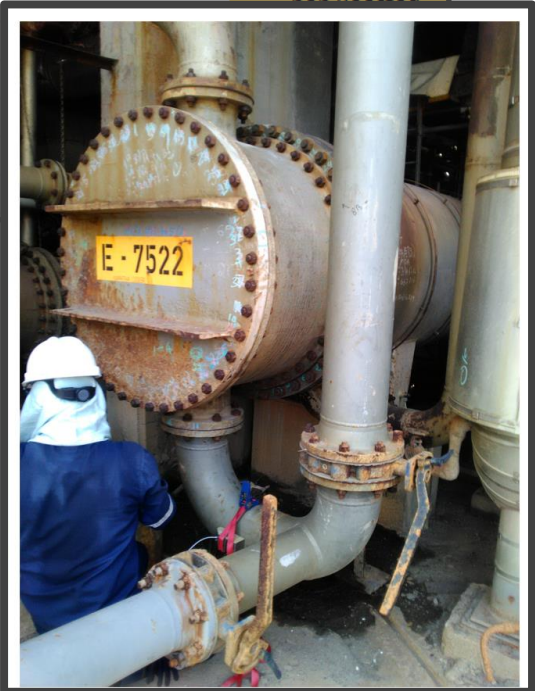
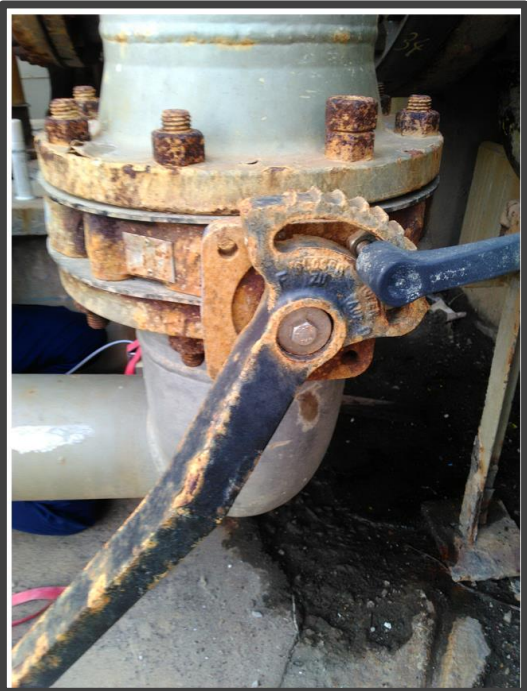
Valve opening % (Actual Vs model)

- 1) SCW flow rate measured as on site were added in model, in total ~70% of flow is measured
- 2) It has been observed that actual valve opening % on site Vs valve opening % in model is **different**.

- 3) Model was indicating **less opening** % of valves required as compared to site valve opening % to match the measured flow rates (So model was giving more flexibility to open valves further to get more flows, however actual was different)

- 4) Therefore to match the site valve opening %, additional pressure drop across heat exchangers were added in model. This suggests that either site SCW network or the HEX are fouled.

- 5) After the above is done, the model is able to exactly match the measured flow rates and site valve opening %, thereby validating the model to match the site condition with fouling.
