# V10173 – Poor Sodium Removal Efficiency

## Background and Timeline:

### Hypothesis:

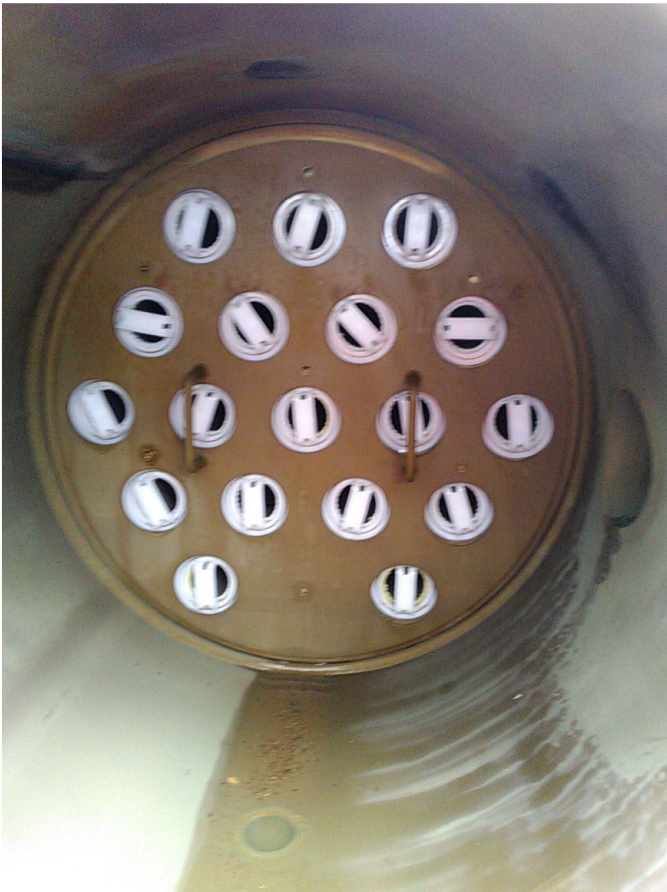
## Old Elements

- High sodium carryover from V-10109 and lower sodium extraction from organic to aqueous phase as a result of V-10109 3 phase separator installation (0-350ppm vs <10ppm past data). Due to change from 2-phase to 3-phase separator operation, there is reduced liquid volume and lower residence time for effective separation.
- The new coalescers is not working as intended (defects) / installation error of the O-ring causing water bypass within the coalescers.

- Monitor for another month – coalescer take some time to achieve optimal performance (e.g. wash train coalescers)
- Determine if the lower sodium removal efficiency is due to issues with the new coalescer elements or higher sodium carryover at V10109 outlet (engage both P&T and vendor).
