# **E9207 aircooler leak learnings**

## E9207 aircooler leak

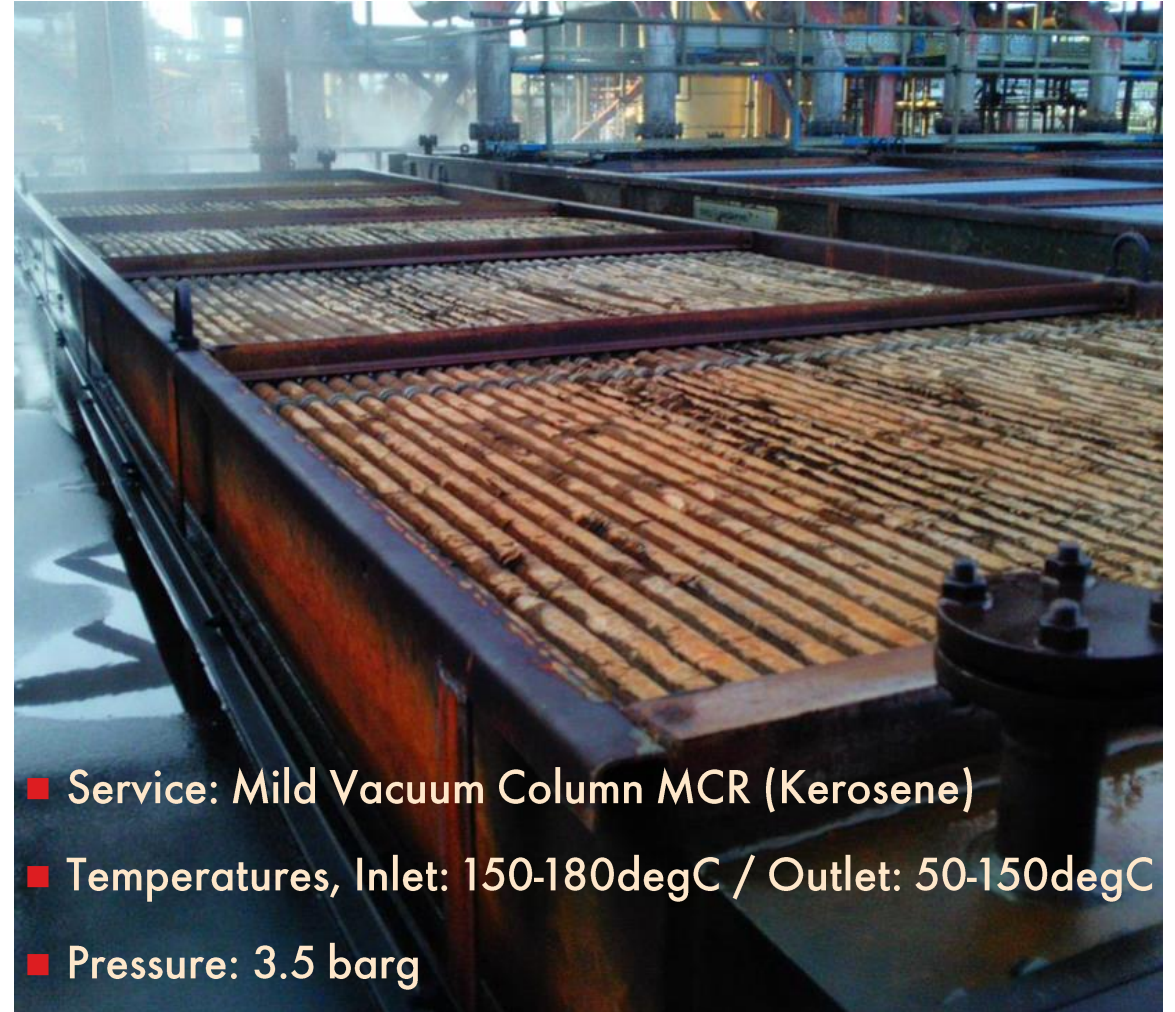
Fig. 12: Tube fins  
Almost fins were slightly deformed at top side.

- Top row finned tube bowing
- Suspected there since 2008
- Damaged finned tubes will be hotter causing more tubes expansion

- Service: Mild Vacuum Column MCR (Kerosene)
- Temperatures, Inlet: 150-180degC / Outlet: 50-150degC
- Pressure: 3.5 barg

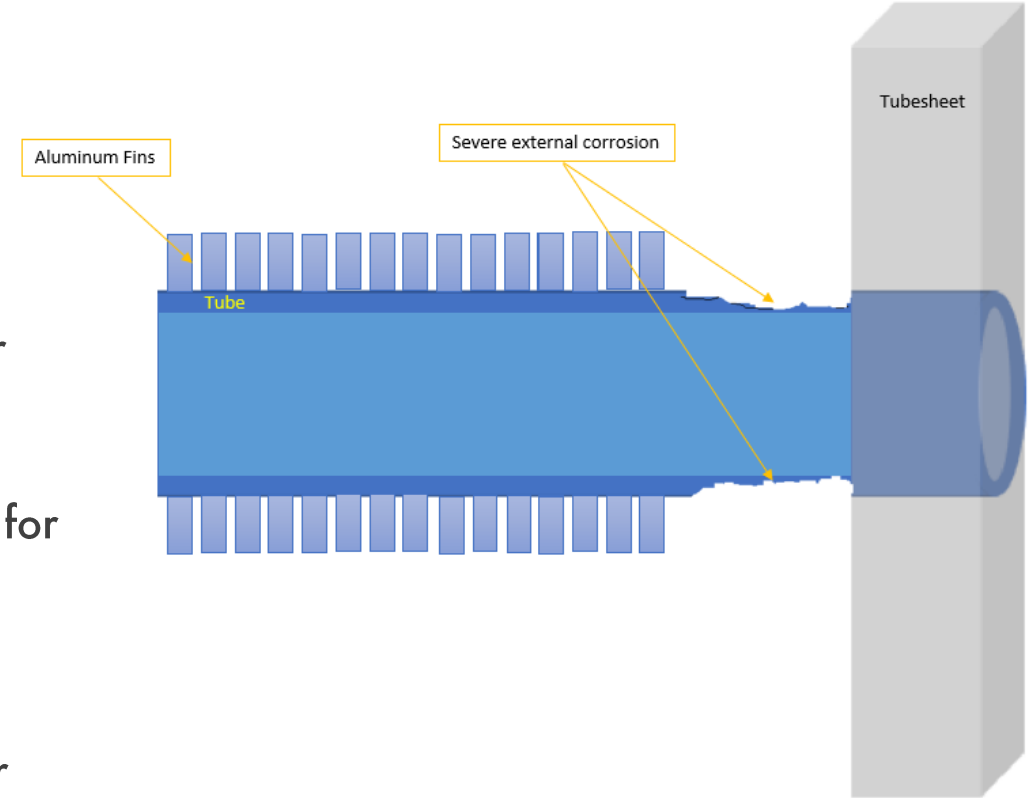
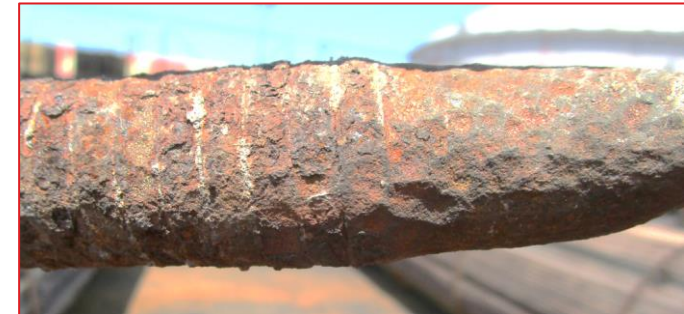
- External Atmospheric Corrosion over long term
- Long Term Corrosion Rate, 2.2mm lost in 38 years = 0.06mm/year
- Corrosion rate looks reasonable in terms of atmospheric corrosion for marine environment
- External aluminium fins also acts as a sacrificial galvanic couple for carbon steel tube hence prevents corrosion at finned section
- Therefore, tube ends are more prone to external atmospheric corrosion

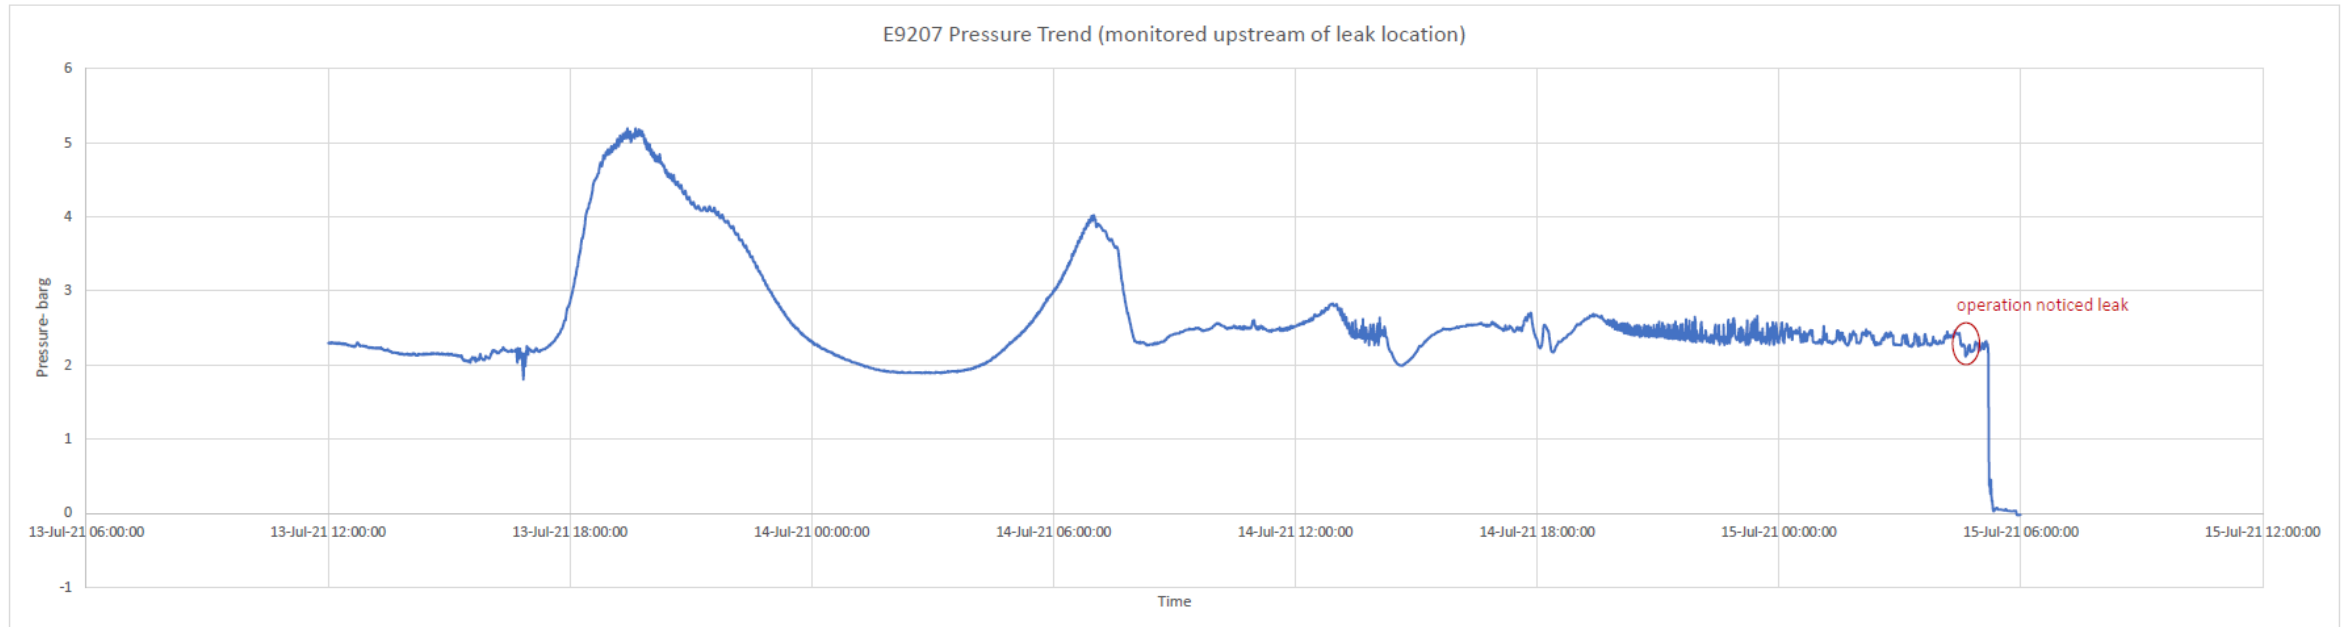
- Pinhole must have been appeared first before the complete rupture/shearing of the tube
- Corrosion scales might have prevented any noticeable leak
- Leak through the pinhole during start-up might have loosened the corrosion scales resulting in overstressing of already thinned down tube which finally sheared under internal pressure and deadweight

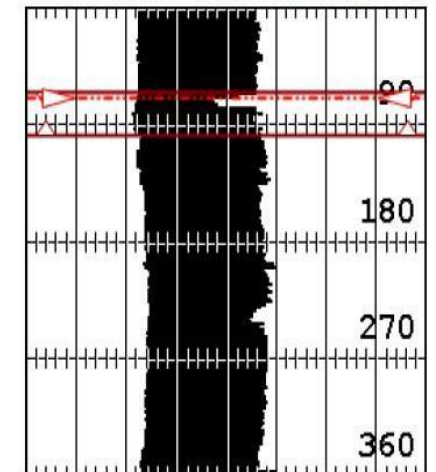
Row: BB Tube: 12

Comments: External Pitting

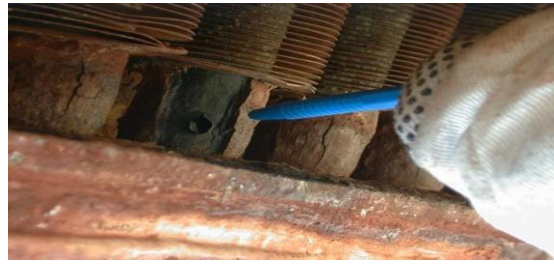
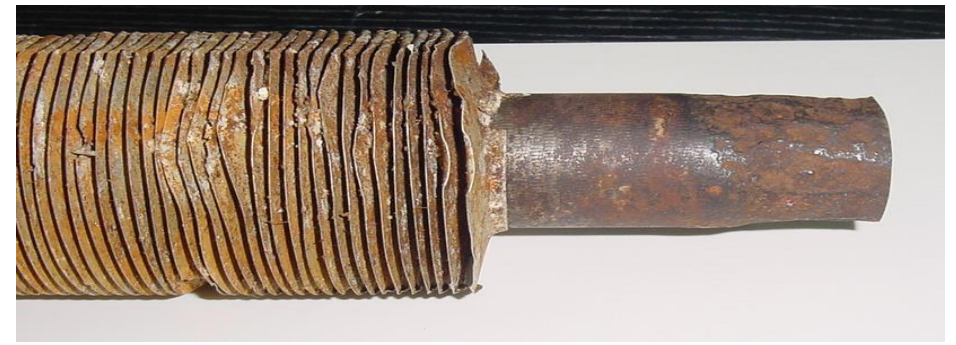
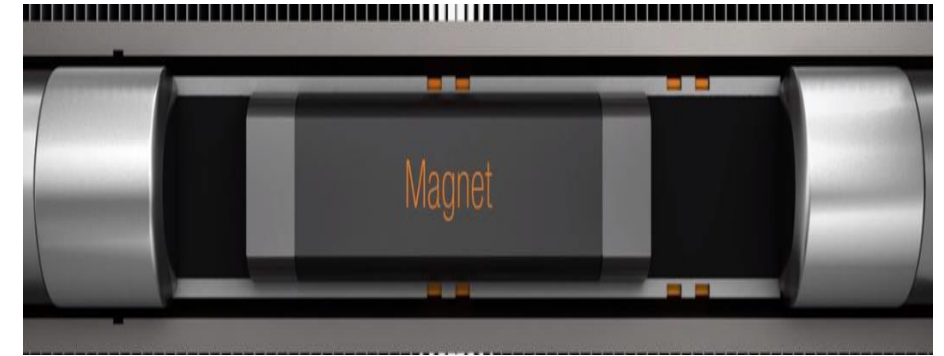
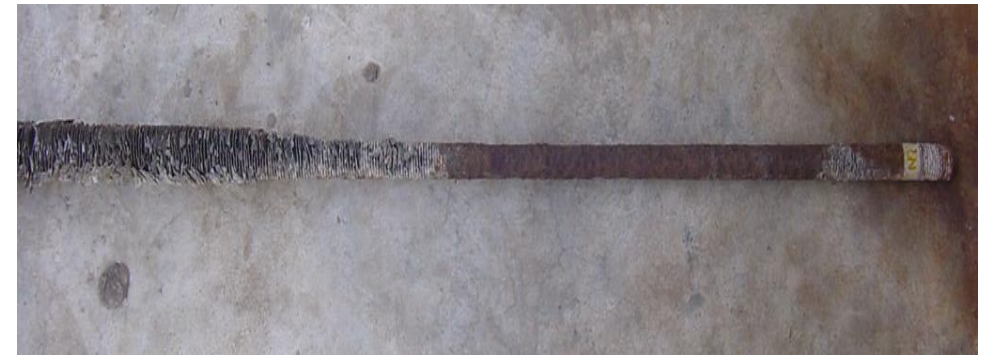
- New technique specially designed for such external corrosion mechanism (not tested in Bukom but trials were successful in Upstream)
- A custom probe head was designed wherein both the MFL and PSEC technique could be performed in one single pass.
- The probe is sensitive to both ID & OD defects and further its unique design enables the detection of corrosion that usually happens in the unfinned section of the tubes in a fin fan cooler tube bundle. The unfinned section is usually around 20 to 30mm long and just after the tube sheet.
- MFL + PSEC (Magnetic Flux Leakage + partial saturated eddy current)
- From the trial it is recommended to carry out 100% screening in all tubes using MFL+PSEC probe and followed by checks with IRIS
